Water Bag and Concertainer Detonation Barricades

ARL-TR-2330

September 2000

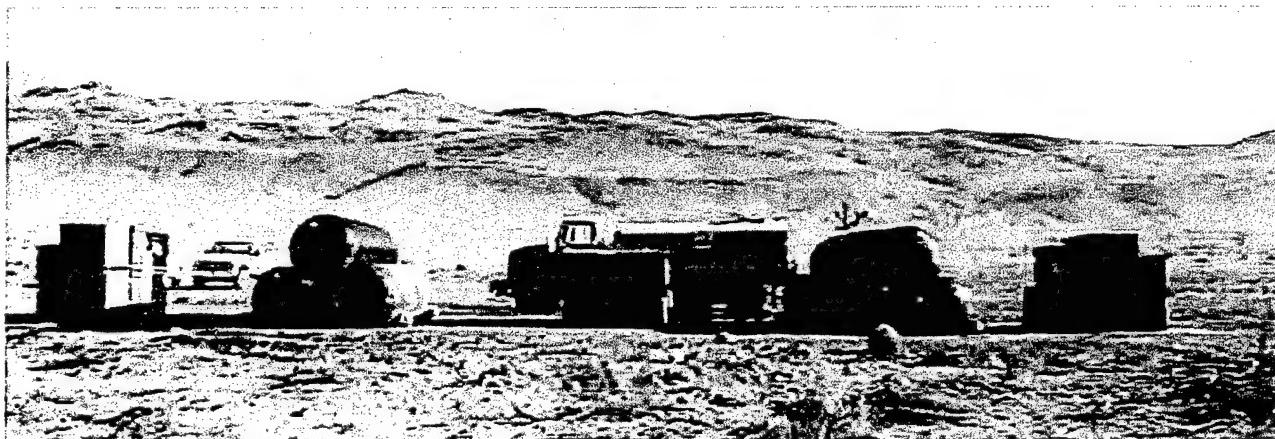
Figure 4. Water Bag Setup for MST 1.1 Hazard Test.

2.1.2 Results. The donor stack fully detonated. Both barricades were destroyed in place, and the water was driven out in a spray at the acceptor stacks. The north end acceptor stack fully detonated, but the south end acceptor stack did not. The secondary explosion is revealed by the smaller dirt column in Figure 5. There was a very large, black-crusted ground area left by the water blast interaction. The cause of the darkening is unknown, but possibly water vapor condenses on carbon particles in the donor explosion TNT after-products and falls as black rain. The particles would have to be very small to be carried by the slight wind and blacken the large area that was observed. Figure 6 shows scattered munitions on the darkened ground.

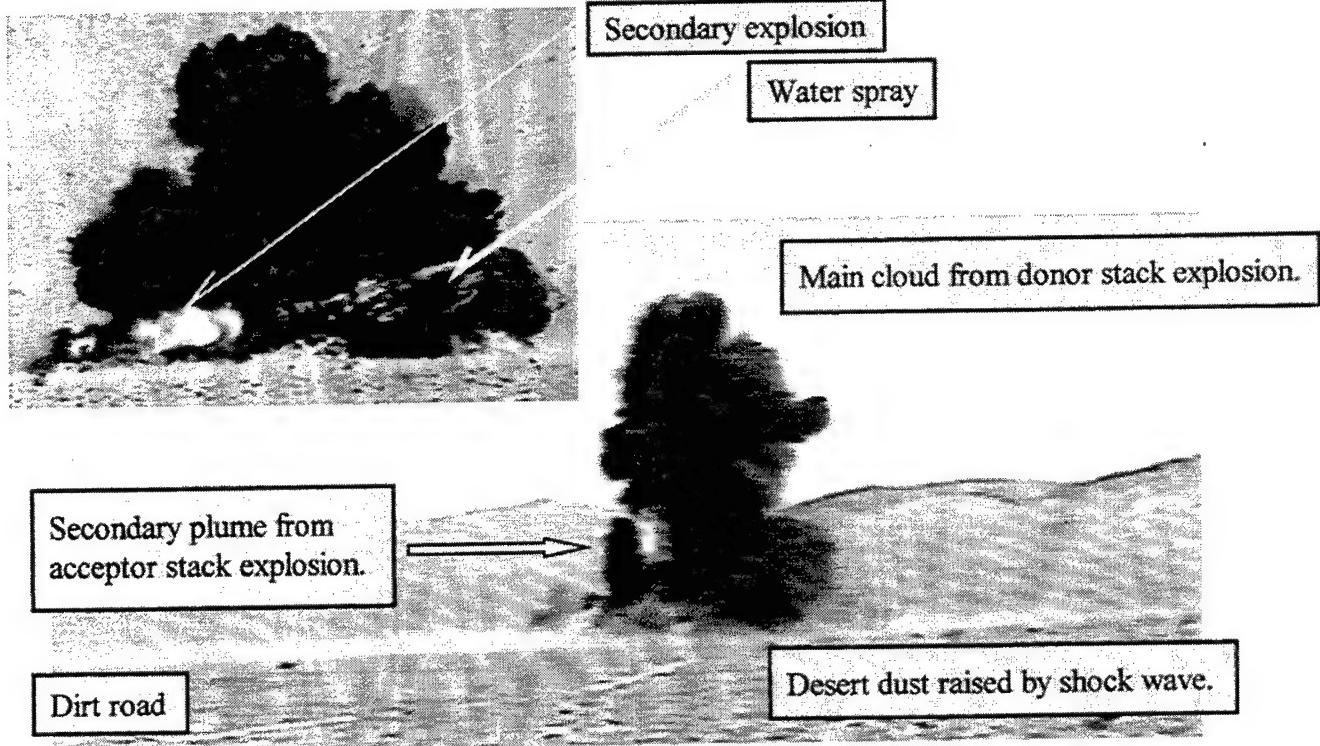
Figure 5. Explosion of North Acceptor Stack Shown by Secondary Dirt Cloud.

* Repeated ground sweeps recovered no munitions at all. In particular, the conspicuous, inert 155-mm projectile encasing the accelerometer was not found; its disappearance further signifies that the north stack entirely detonated.

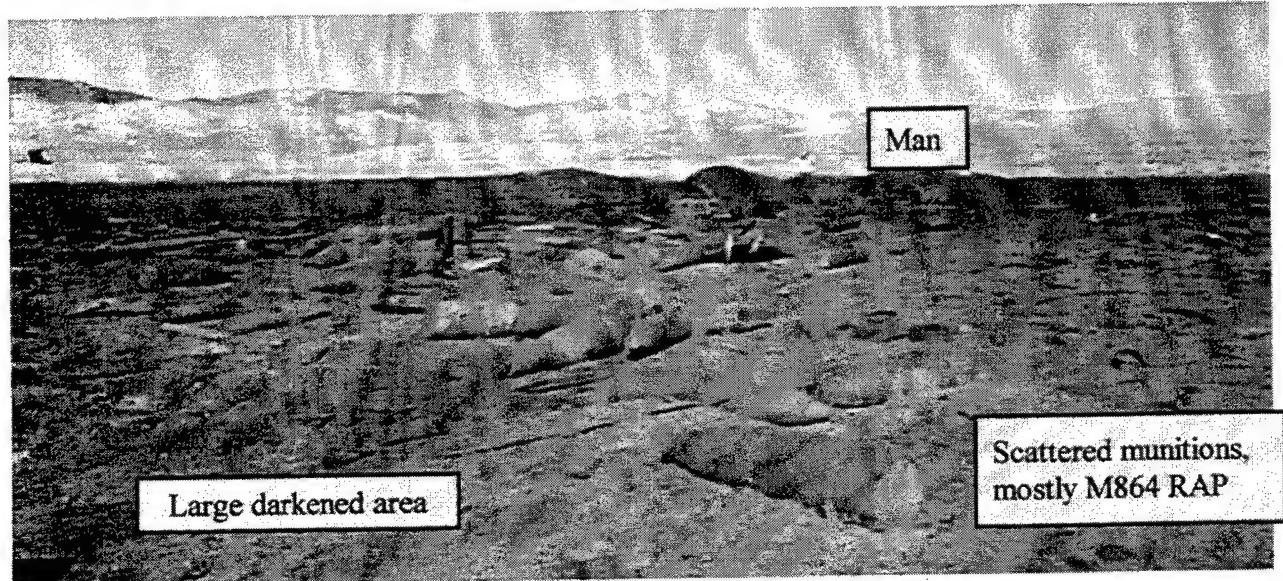
Figure 6. Scattered Munitions and Darkened Ground From Water Bag Test.

Other signs of the secondary explosion are the mangled steel witness plates that were under the acceptor stack, the creation of a large crater north of the (separate) donor stack crater and no crater south of the donor stack crater, the disappearance* of all acceptor munitions from the north stack, and the explication of high-speed film. Selected frames of the event are shown in Figure 7. After interpreting the film, we concluded that after a long delay from stack initiation (camera speed unavailable), a single-point initiation occurred on the ground 10 ft behind the acceptor stack face (probably in an M2 munition), and detonation propagated to all other munitions of that stack.

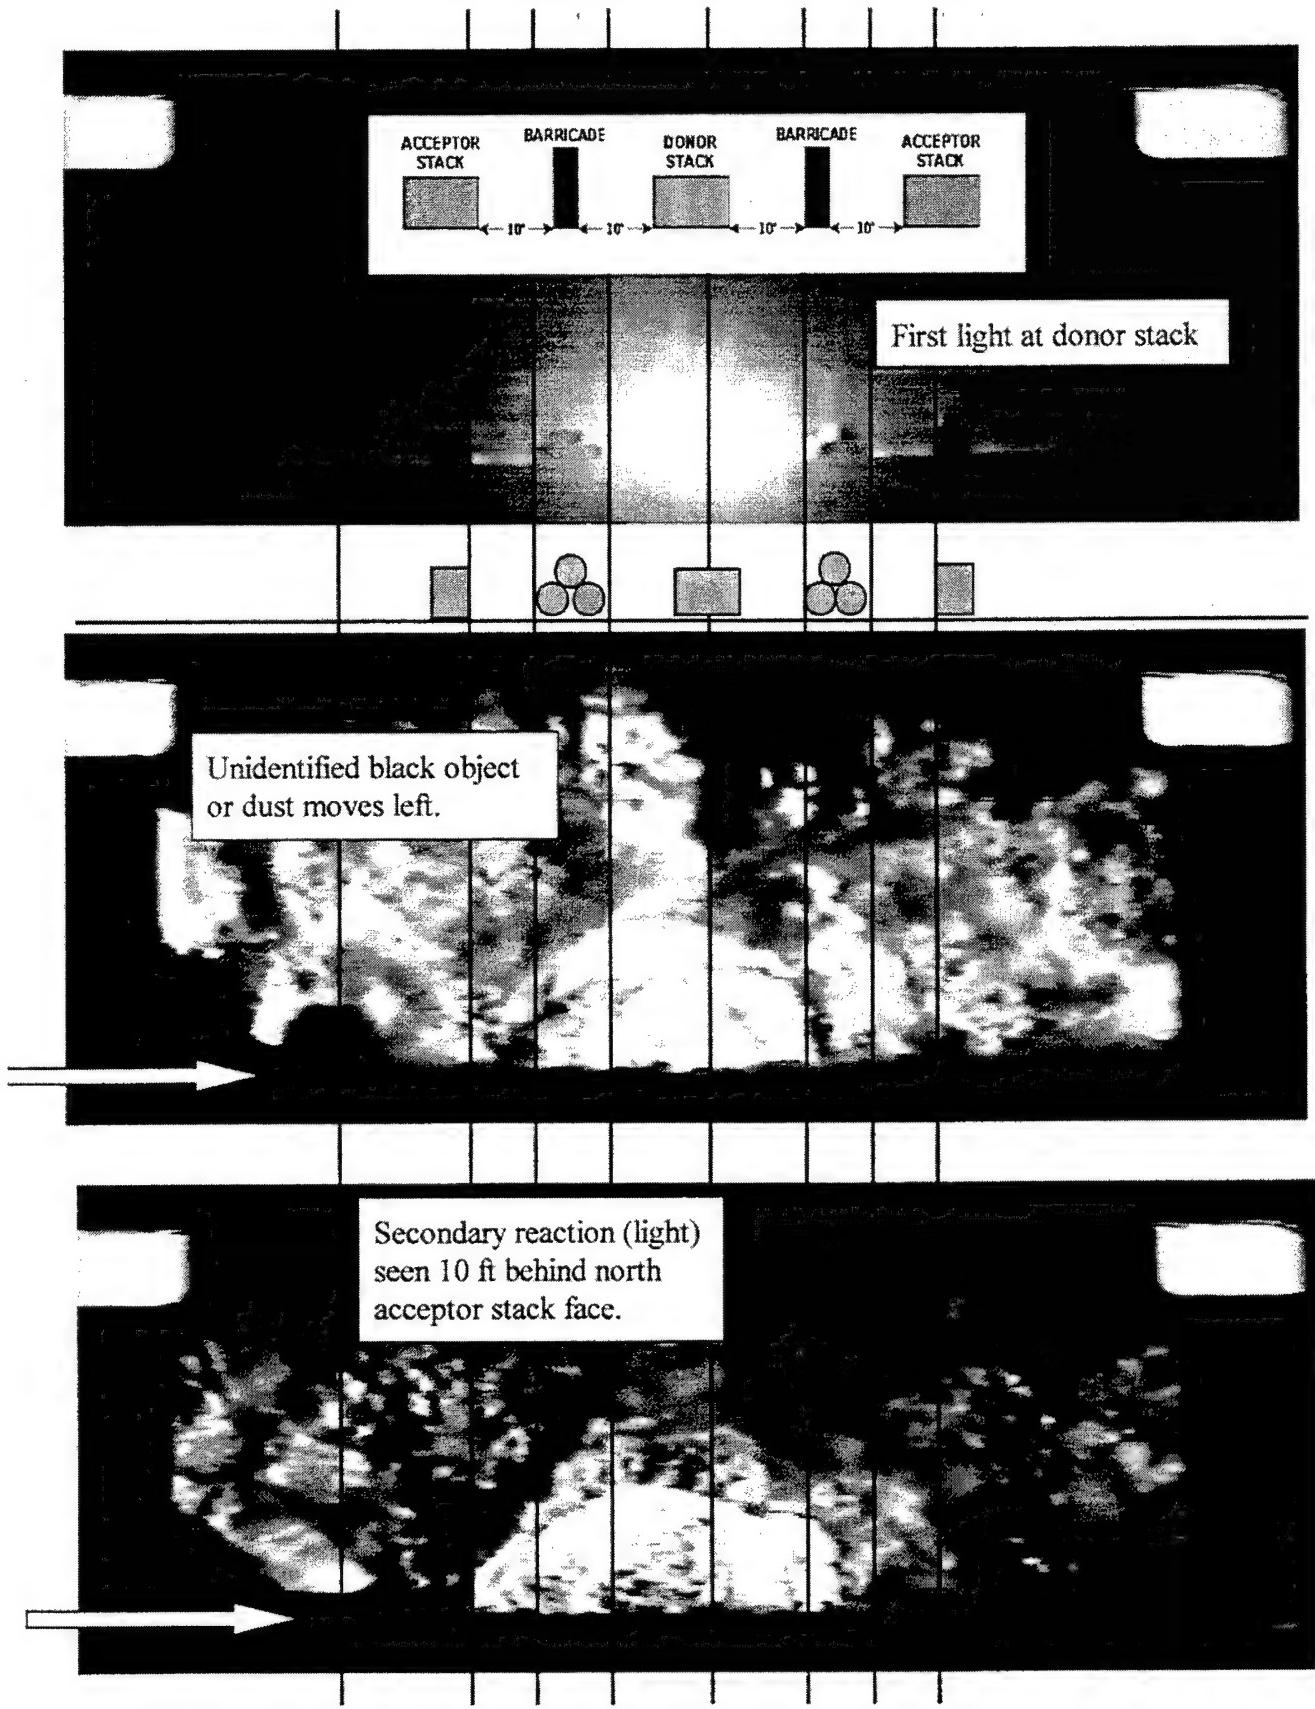
Figure 7. Secondary Explosion in North Acceptor Stack of Water Bag Test.

The acceptor stack that detonated did so after a considerable delay, as indicated by the fact that the point of initiation is seen on film to be 10 ft behind the barricade side of the stack. It is clear that water impact did not cause prompt initiation. In both barricade tests, some of the lightly packaged and constructed M2 shaped charge hole diggers were ripped open, and crumbled Pentolite explosive was scattered near the item (see Figure 11). It is possible that a deflagration to detonation transition occurred in this broken Pentolite, but this is unlikely. M2A3 hole diggers (Composition B fill) were shown by Lyman et al. (1994) to be very sensitive to crushing impacts. This is because the explosive is almost completely unprotected. We suspect that the crushing of the hole diggers caused the initiation. The likeliest cause of the initiation was mutual impacts in a group of translating munitions that crushed the explosive. Possibly the light and sensitive M2 hole digger collided with others or with the backing, which were heavy, semistationary M107 projectile pallets, and the Pentolite was crushed* and initiated. If collision and crushing caused the initiation, then it could just

The acceptor stack probably detonated because the M2 shaped charge hole diggers collided with themselves or against other slower traveling munitions; the driver explosive was then crushed and initiated, exploding the swarm.

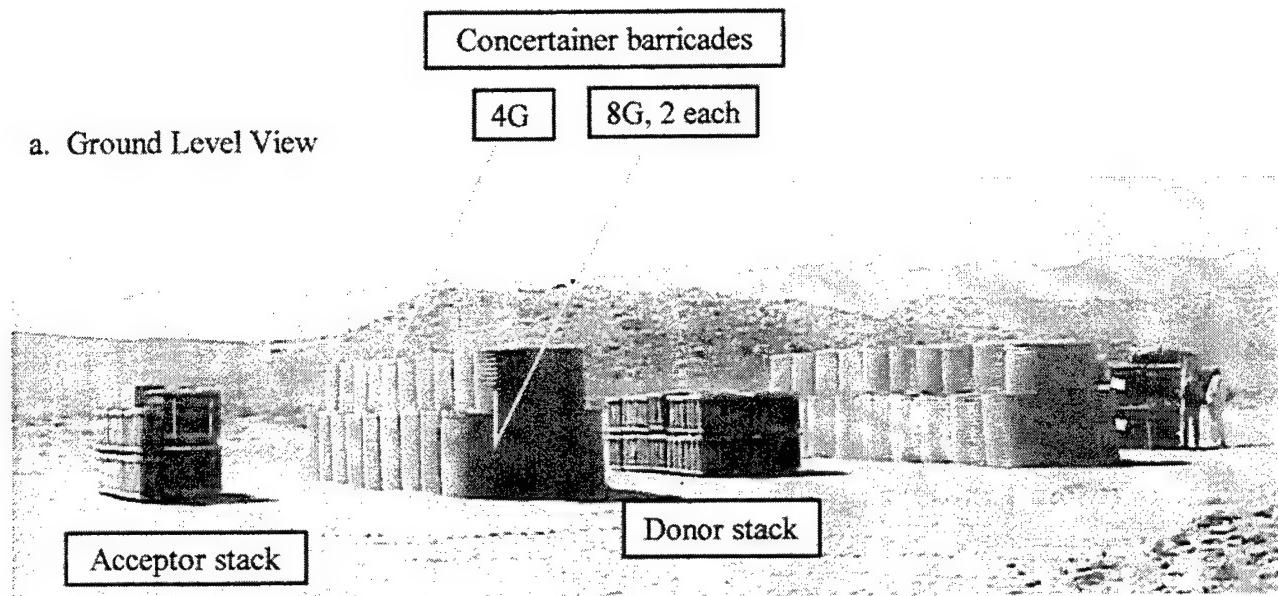
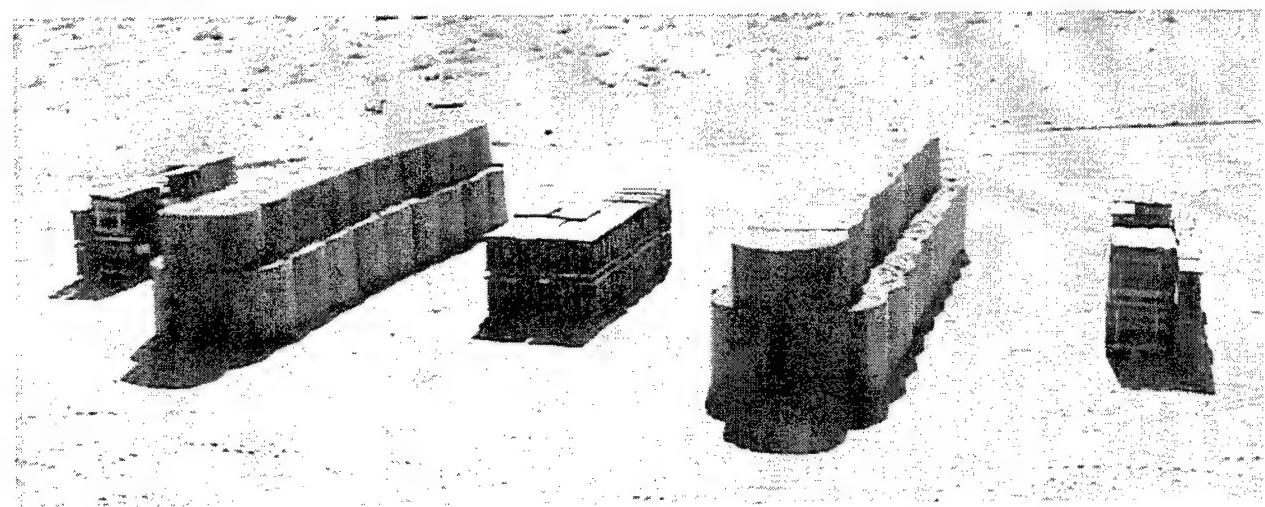
Figure 8. Concertainer Setup for MST 1.1 Hazard Test.

No munitions from either stack had fragment marks. In other words, the upper (4G) bin at a thickness of 60 in and linear density of 1,600 lb/ft stopped fragments from the 155-mm HE projectiles. This result was expected from Johnson (1966), who found that fragments off of the 8-in howitzer projectile M106 penetrated less than 4 ft of sand; therefore, the Concertainer barricade we designed (Appendix A) was thicker than needed. The accelerometers read 5,000 g on the north stack and 3,200 g on the south stack.

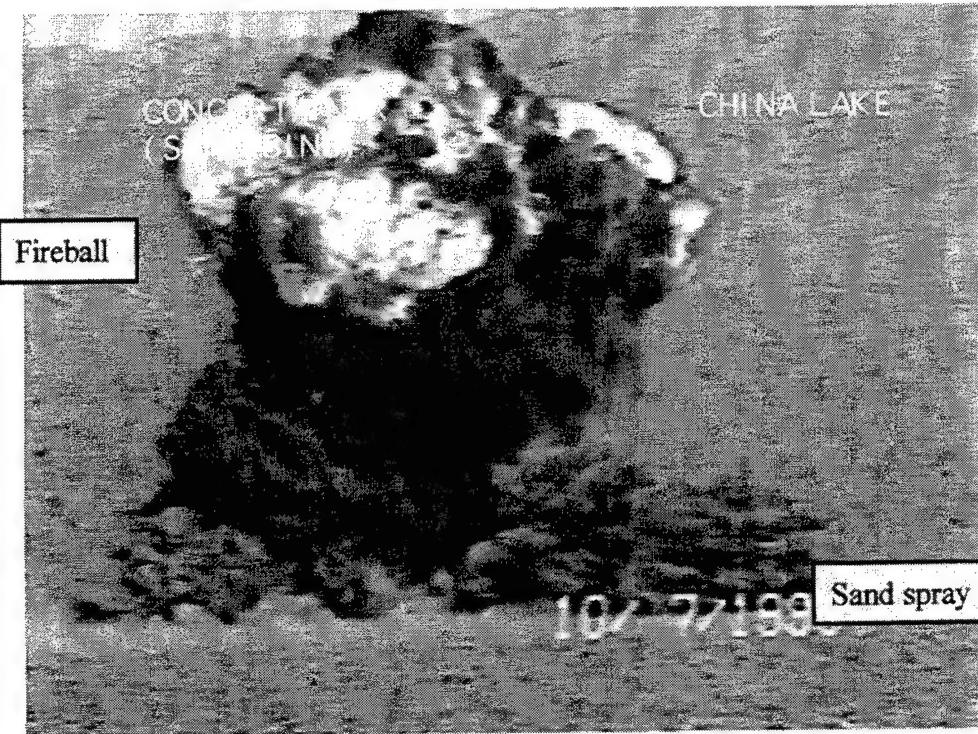
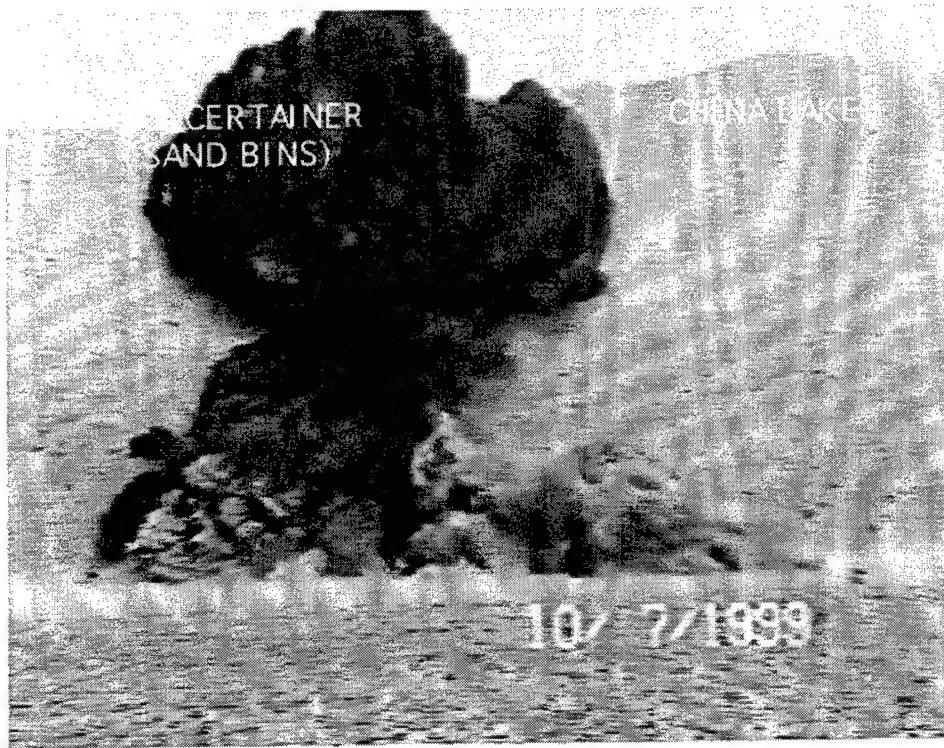
Figure 9. Explosion Cloud and Sand Spray From Concertainer Test.

2.2.2 Results. The donor stack fully detonated. Both barricades were destroyed in place and the sand was driven out in a spray far beyond the acceptor stacks, as shown in Figure 9. Neither acceptor stack detonated, as revealed by the curled but intact steel witness plates under the stack, the lack of acceptor craters, the recovery of the acceptor munitions, and a review of high-speed film. All stack items survived being translated close and far, and all were recovered. Views of thrown munitions are shown in Figure 10. The heavy RAP projectiles from the front of the acceptor stack are the closest to the witness plate. No baseplate on the RAPs was dislodged, so no submunitions were spilled. Figure 11a shows that the blast damaged the light packaging of the M2 hole digger, which is three nestled SCs wrapped in plastic and put in a narrow wood box. Bunches of boxes are banded together. Figure 11b shows an SC broken open, exposing the driver explosive.

a. Early time showing fireball and large sand spray to right.

b. Later time showing fireball nearly gone and sand at maximum throw.

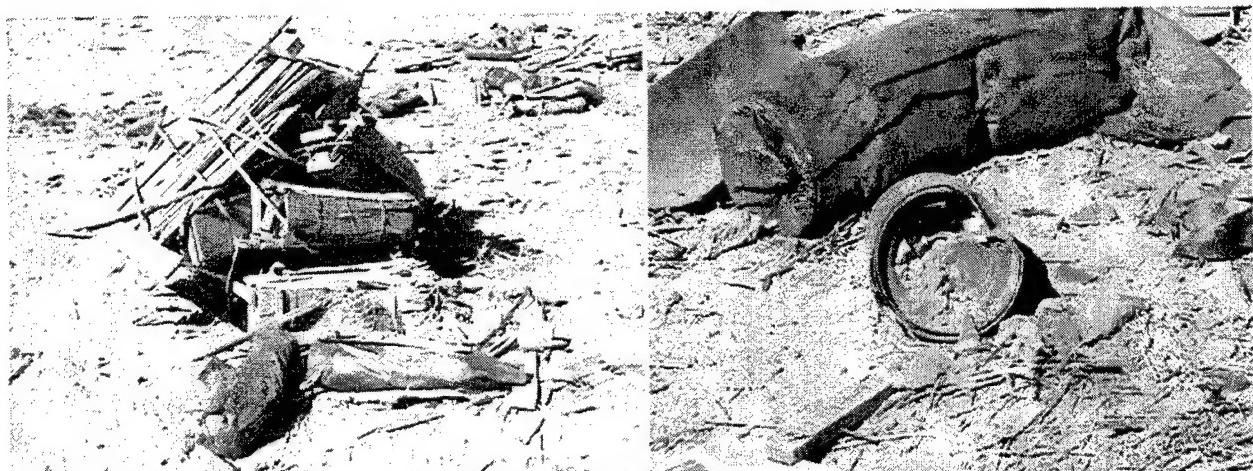
Figure 11. Crumpled M2 Hole Digger in Concertainer Test.

a. Smashed shipping container of M2s.

b. Exposed explosive from broken SC.

^d Because of weak packaging and weak casing, the explosive will likely be crushed from the collisions. Also, exposing HE to the fireball is possible, allowing DDT to occur. Water spray will likely douse DDT, but this initiation mode remains a possibility with sand bins (Concertainer).

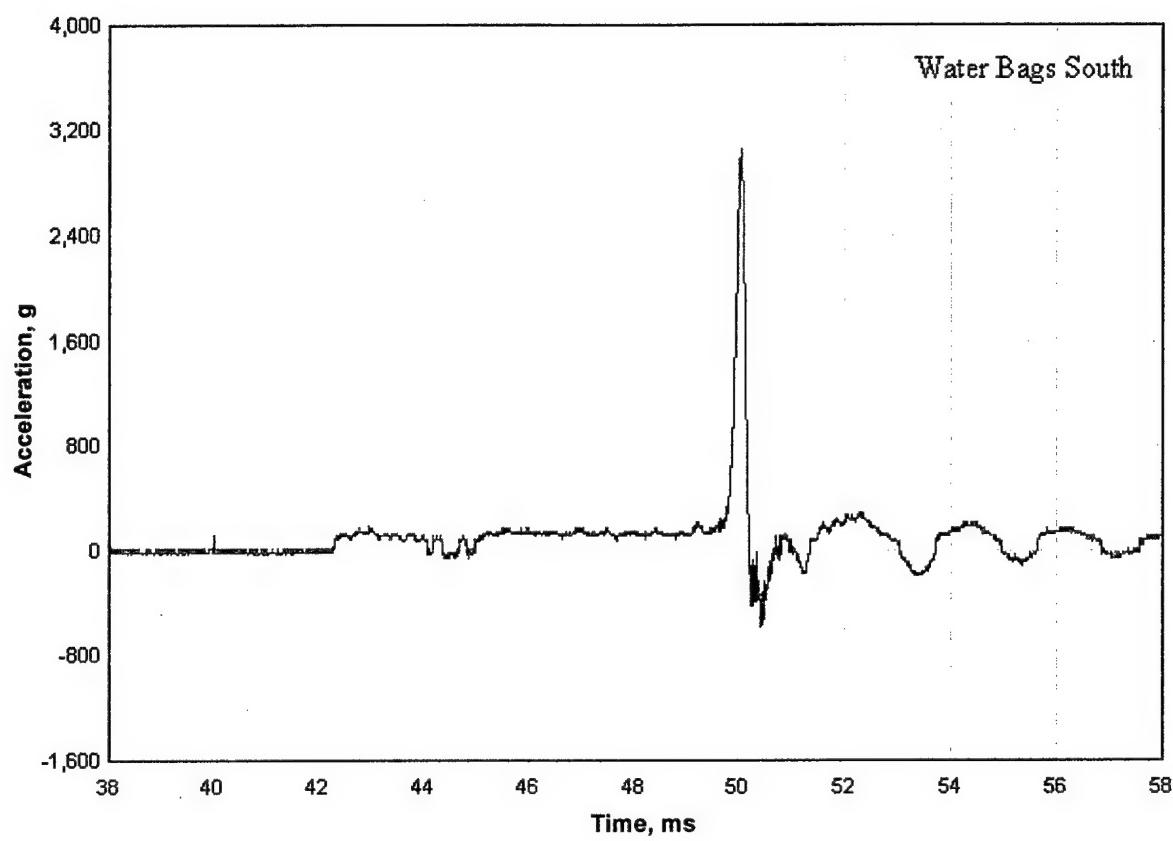
In the water bag test, one of the acceptor stacks went high order, and its HDAS round was not found. Figure B-2 shows the one water bag record. For the Concertainer test, both rounds were recovered, and the data are shown in Figure B-3. The acceleration measured in both tests was between 3 and 5 kg, much below a full-scale record. Even so, because of the wide dynamic range of the HDAS, clean data were extracted.

Ground shock probably triggered the HDAS. That short delay time from donor stack detonation until ground shock arrival is not included on the records. Neglecting it for the nearly identical size tests, the motion of the water bag acceptor stack begins 50 ms after time zero and after 70 ms for the Concertainer acceptor stacks.
